December 19, 2000

Log #: TS-0003

Update for TS-0002 Screws Backing Out of DT600 DPY 102 186 After Prolonged Use

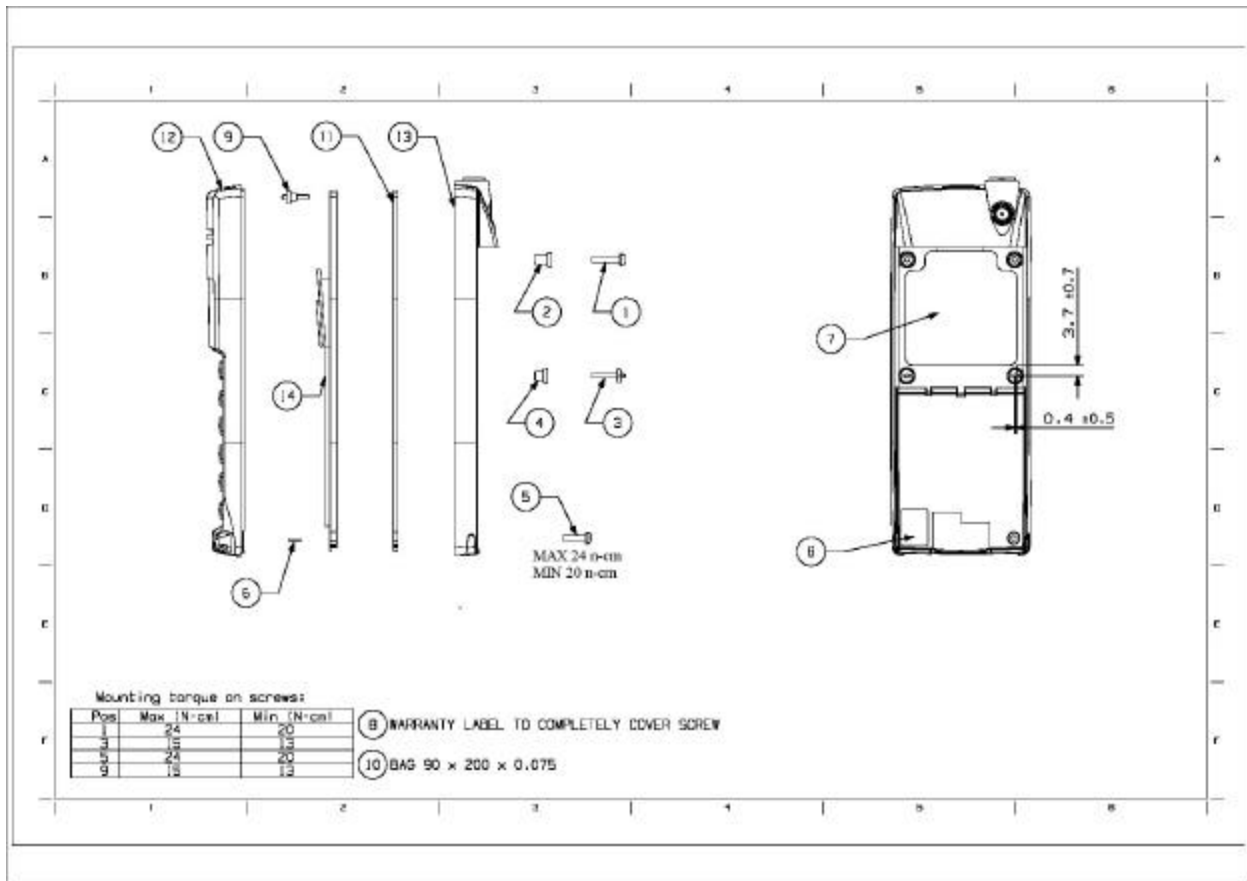
Figure 1

There have been instances where two screws used to fasten the front cover to the back cover of the DT600 Handset have become loose causing poor physical integrity, intermittent keyboard operation, intermittent microphone operation and varying RF characteristics (poor signal strength). The Torx Type screws of concern are located at the bottom of the Handset in the battery compartment (See Figure 1, Identifier 5). One of the screws is located behind the Warranty Void seal (Identifier 8). Simply tightening the screws at any other torque than what is specified could possibly damage the threaded inserts for the front cover. If the inserts are damaged, the handset will become unusable and must be replaced. The torque tolerances for the two bottom screws (Identifier 5) located in the battery compartment are 24 N-cm Max and 20 N-cm Min. A preventive maintenance practice is recommended for all users of the DT600 handset.

There have also been instances where the two spanner screws (see figure 1, identifier 3) became loose. A special spanner bit must be used to tighten the spanner screws to a specified torque tolerance of 15 N-cm Max and 13 N-cm Min. The vendor information to acquire the parts and tools needed to tighten the spanner bits is included in below.

Every three months the DT600 handset should be inspected and the indicated Torx and spanner screws should be tightened as specified. The specifications are provided in Figure 1. Removing the Warranty Seal will not void the warranty of the handset.

Refer to the Figure and use a suitable Torque Driver, such as the one recommended, to tighten the screws with a force within the torque tolerance guidelines. If the Warranty Seal (Identifier 8) is displayed, remove it and discard. Tighten the screws (identifiers 3 and 5) to the specified torque using a calibrated torque driver. The torque drivers will come pre-calibrated and cannot be adjusted by the user so separate tools are needed for each set of screws.

If the screws are not tightened using the provided guidelines, the handset can be permanently damaged.
